Pre-Demolition Hazardous Materials Survey Report

Xaxli'p First Nations

160 Main Reserve, Xaxli'p First Nations – Main Building

Apex File Number: HOM23-102.01

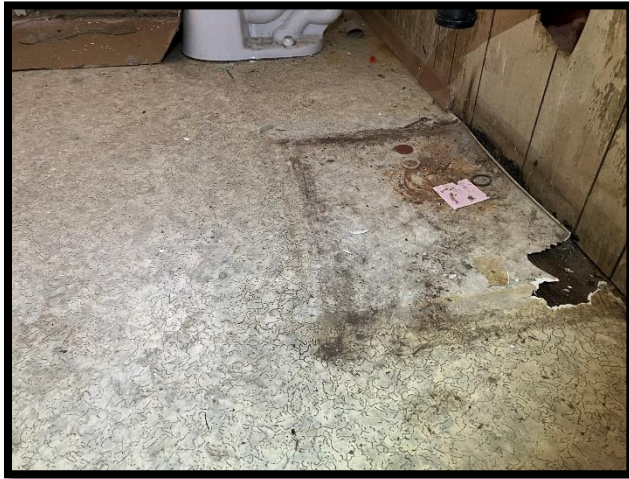
Asbestos was detected in the Gravel Pattern Vinyl Sheet Flooring (S18) within the Main Floor: Office Bathroom (Loc. 8).

- All asbestos-containing material must be removed using safe work procedures and practices prior to demolition activities.
- An asbestos risk assessment must be performed by a qualified professional prior to demolition work occurring to determine the exposure risk to workers and other persons.

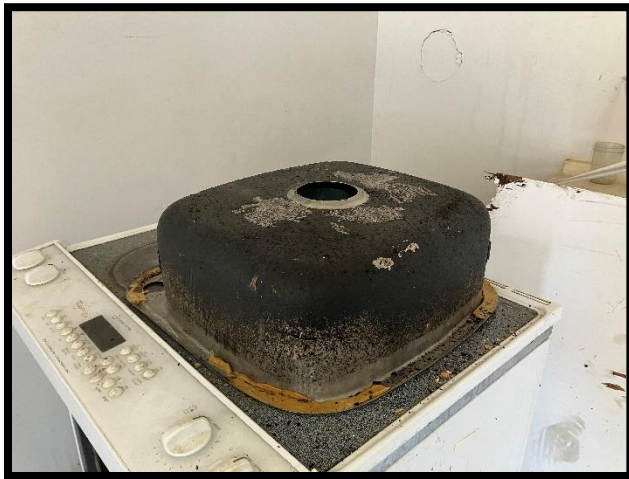
Asbestos was detected in the Sink Mastic (S21) applied to the Underside of the Sink within the Main Floor: North Kitchen (Loc. 6).

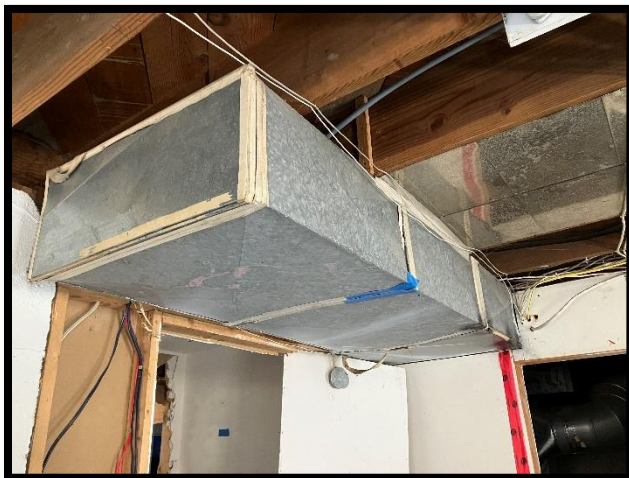
Asbestos was detected in the Duct Tape (S23) applied to HVAC Ducting Systems within the Basement: South Area (Loc. 15) and Furnace Room (Loc. 17).

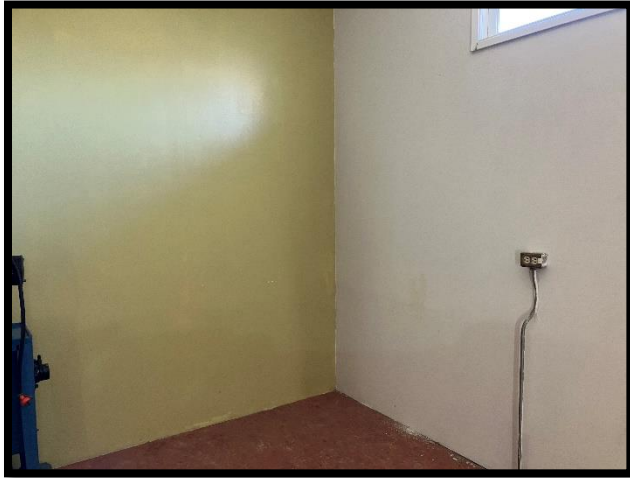
Lead was detected in the Mustard Paint (L02) applied to Drywall Wall Boards within the Main Floor: Main Room (Loc. 1).

- Emergency light batteries should be removed and recycled prior to demolition.
- Proper procedures and documentation such as safe work practices, an exposure control plan, risk assessments and/or other controls must be developed if paints containing lead are to be removed or disturbed.

- Non-recyclable materials coated with paints containing lead should be submitted for lead leachate analysis to determine method of disposal subject to the requirements of the landfill selected for disposal.

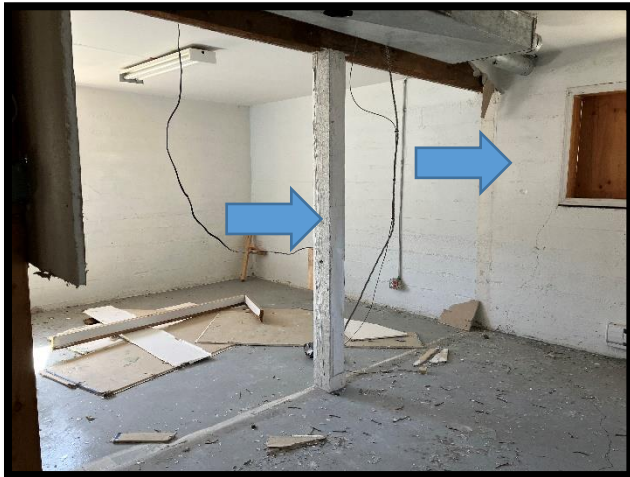
Lead was detected in the White Paint (L06) applied to Wood Pillars within the Basement: Room 9 (Loc. 12), North Room (Loc. 13), South Area (Loc. 15) and Room 5 (Loc. 16).

Lead was detected in the Light Blue Paint (L09) applied to Cinderblock within the Basement: South Area (Loc. 15).

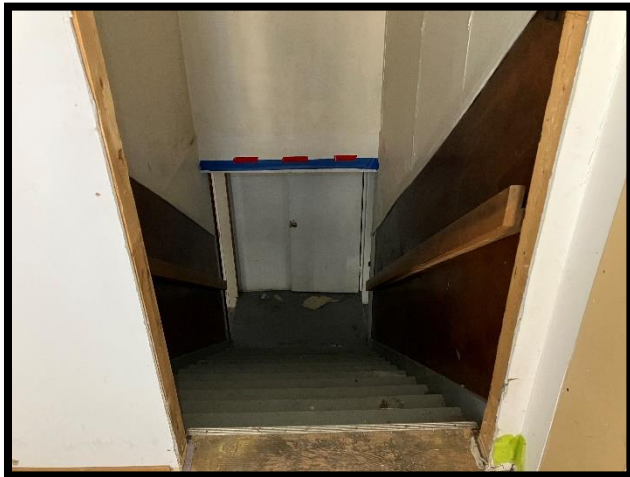
Lead was detected in the Blue Paint (L11) applied to Wood Stairs within the Basement Stairwell (Loc. 11).

Lead was detected in the White Paint (L12) applied to Compressed Cellulose Board within the Basement Stairwell (Loc. 11).

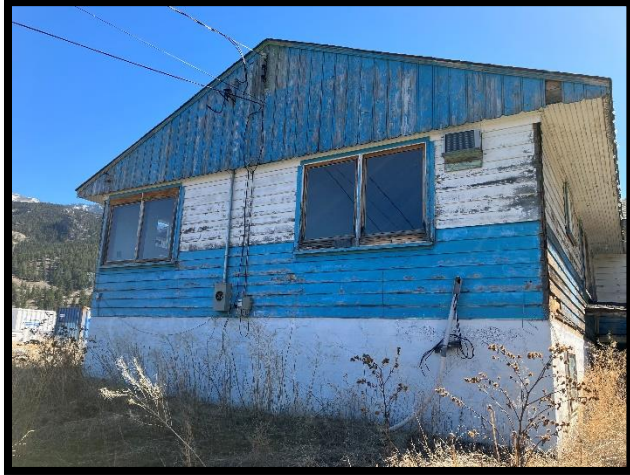
Lead was detected in the White Paint (L13) applied to Wood on the Exterior.

Lead was detected in the Blue Paint (L14) applied to Wood on the Exterior.
