Pre-Demolition Hazardous Materials Survey Report

Xaxli'p First Nations

160 Main Reserve, Xaxli'p First Nations – Main Building

Apex File Number: HOM23-102.01

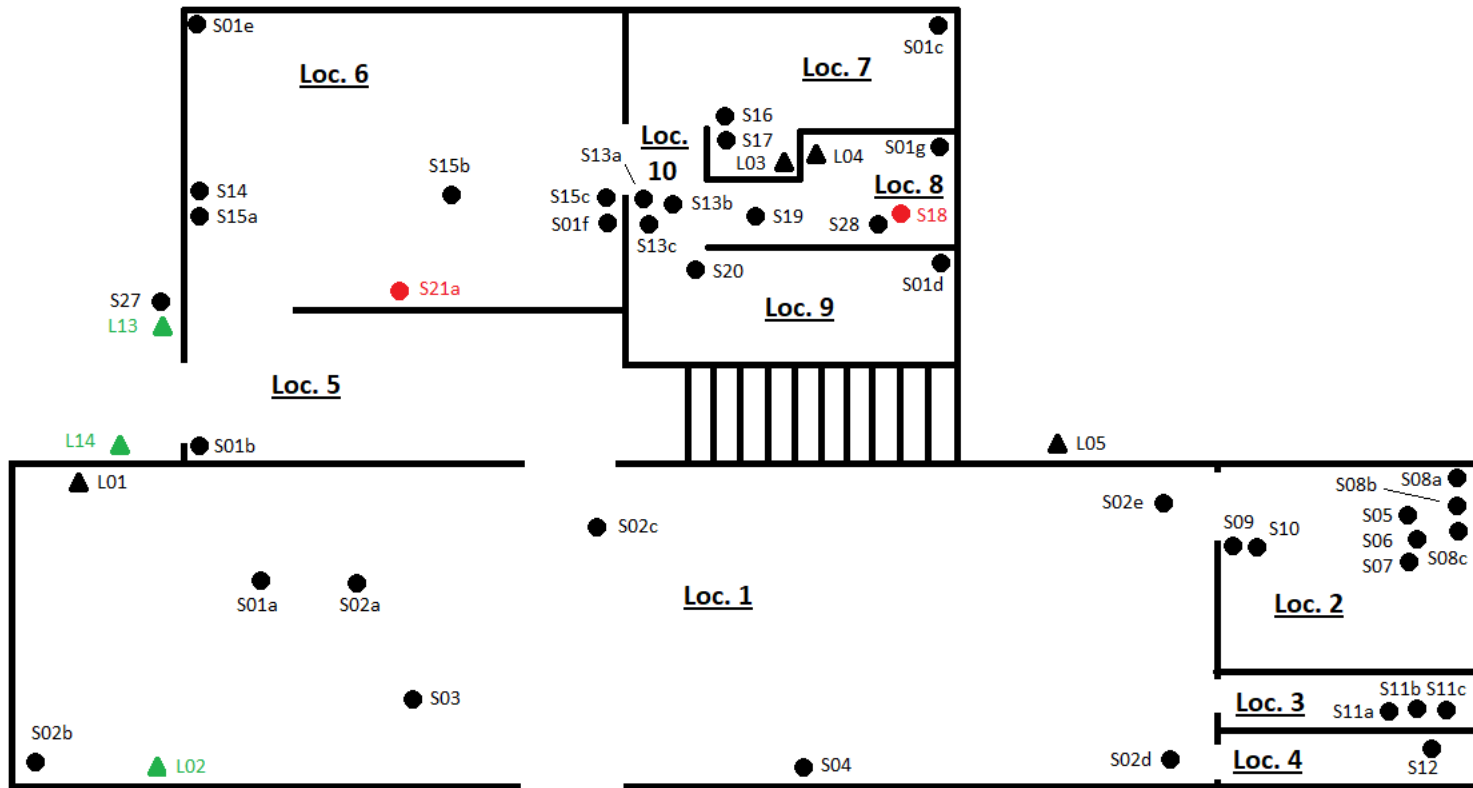
Main Floor Locations

- 1 - Main Room
- 2 - Main Room Kitchen
- 3 - Main Room Bathroom 1
- 4 - Main Room Bathroom 2
- 5 - Main Landing
- 6 - North Kitchen
- 7 - Office 1
- 8 - Office Bathroom
- 9 - Office 2
- 10 - Hallway

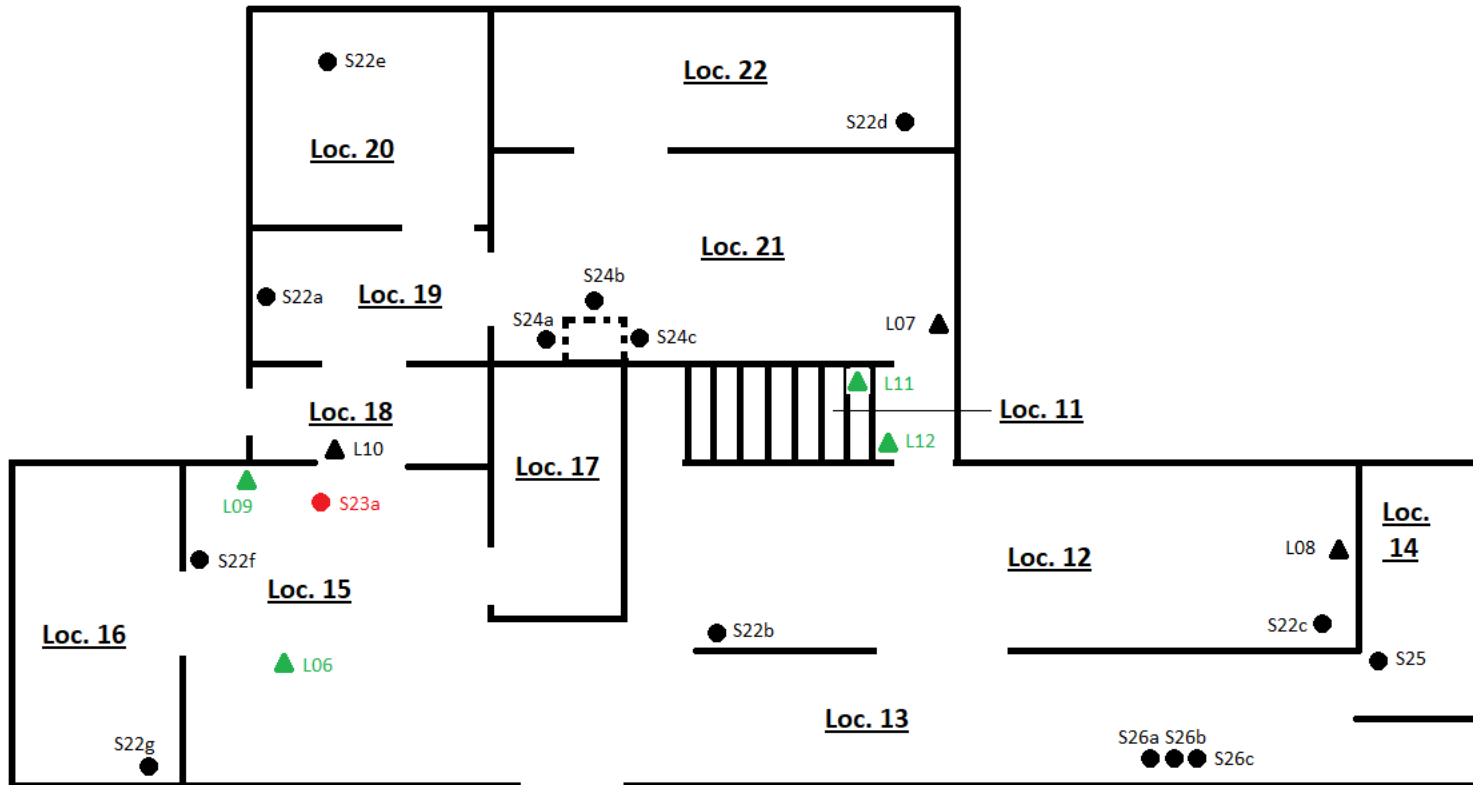
Basement Locations

- 11 - Stairwell
- 12 - Room 9
- 13 - North Area
- 14 - Bathroom 1
- 15 - South Area
- 16 - Room 5
- 17 - Furnace Room
- 18 - Entry
- 19 - Hot Water Tank Room
- 20 - Storage Room
- 21 - West Area
- 22 - Room 3
